Mediterranean Corridor, Bosnia and
Herzegovina - Croatia CVC Road
Interconnection, Subsection: Konjic
(Ovcari) - Prenj Tunnel - Mostar
North

Gap Analysis & ESIA Disclosure Pack

Volume 1: Environmental and Social
Impact Assessment Report

Chapter 13 Soil

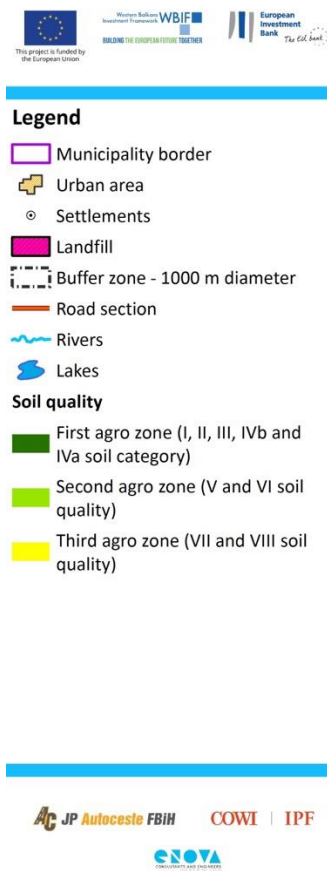
Figure 13-2: Land categorisation in the Project area – Mostar side

As shown in the figure above, the Project area is mostly uncategorized in terms of the soil quality values, except for the part of the route passing through Konjic urban area, area of the Konjic Bypass in the alluvium of Neretva River, and before Mostar North Interchange.

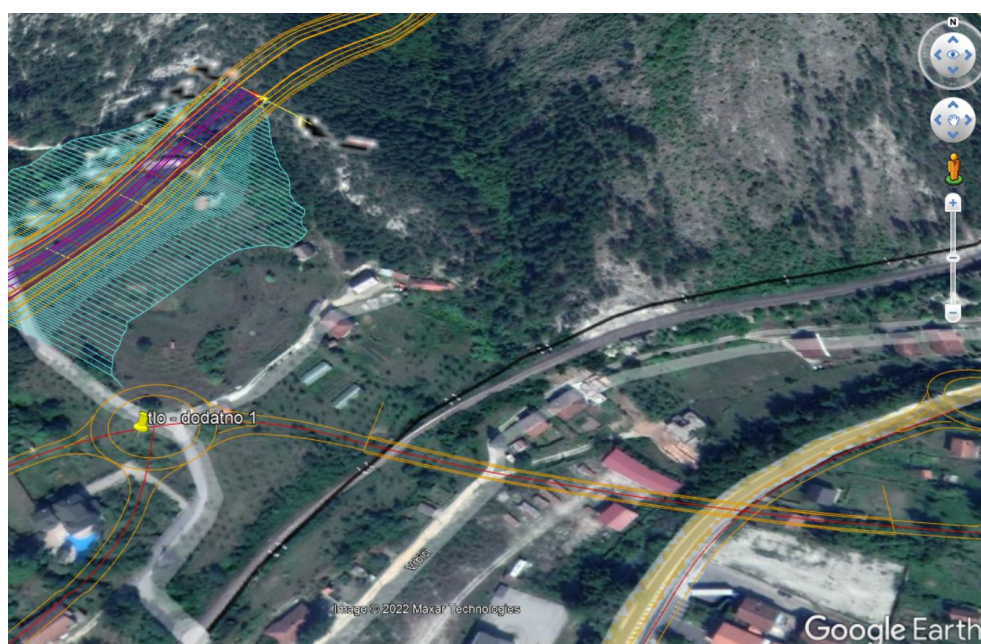
Figure 13-11: Beginning of the Konjic Bypass in Ovcari

Ordinal number	Description of the SP	Location
SP 1 – Ovcari	Beginning of the Konjic Bypass in Ovcari	N: 43°40'11.86" E: 17°58'35.90"
SP 2 – near the Konjic landfill	In the settlement near the municipal solid waste landfill site	N: 43°39'38.46" E: 17°57'15.81"

According to the structure, the soil is powdery-loamy and in accordance with the limit values shown in the *Rulebook*, the tested soil samples **meet the limit values** according to the soil type.

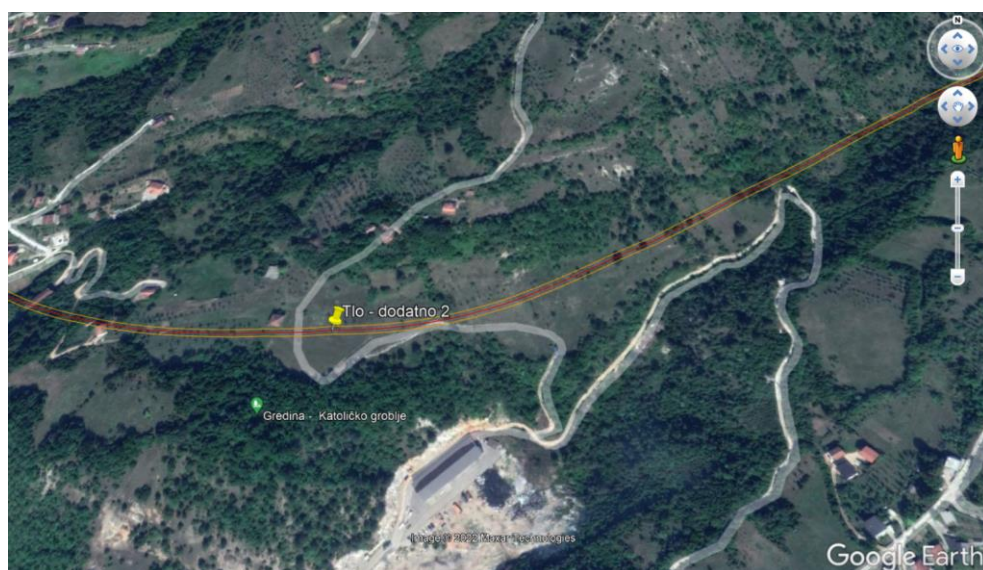
Figure 13-12: Settlement near the municipal solid waste landfill site

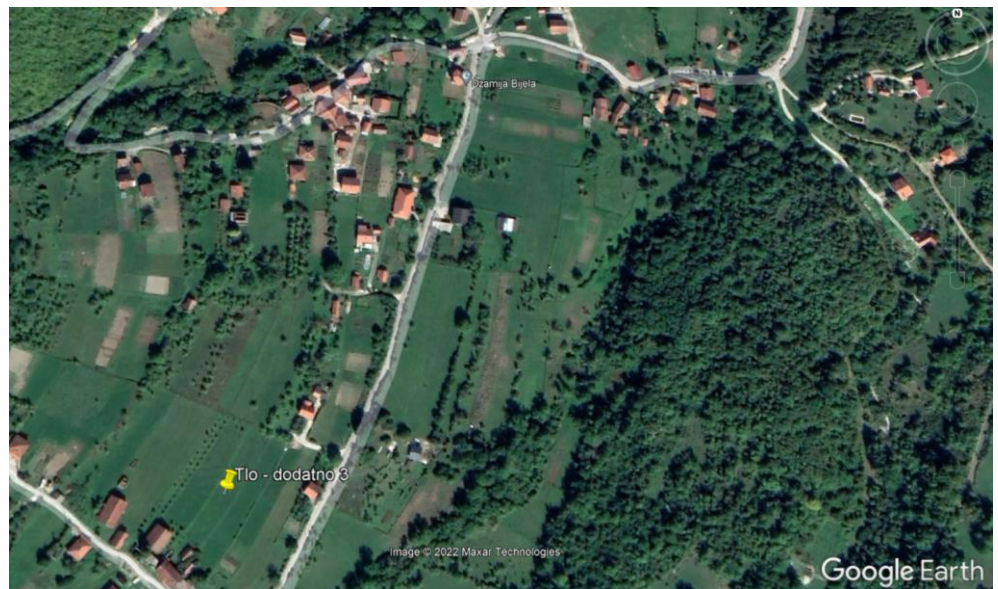
Figure 13-13: Access Road in the settlement Bijela

Ordinal number	Description of the SP	Location
SP 1 – Bijela	Access road in the settlement Bijela	N: 43°36'16.86" E: 17°56'43.92"
SP 2 – HP Investing site	Access road near the HP Investing industrial site	N: 43°26'40.13" E: 17°51'49.45"
SP 3 – Prigradjani	Access road in the settlement Prigradjani	N: 43°27'39.68" E: 17°52'25.22"

Based on the test locations and surrounding environment, SP 1, SP2, and SP 3 can be considered as agricultural land. According to the structure of the soil samples, the soil is sandy and is evaluated against the limit values given in the Rulebook. All parameters for all three analysed soil samples **meet the limit values** stipulated by the *Rulebook on determination of permitted amounts of harmful and dangerous substances in soil and their testing methods* except for zinc as follows:

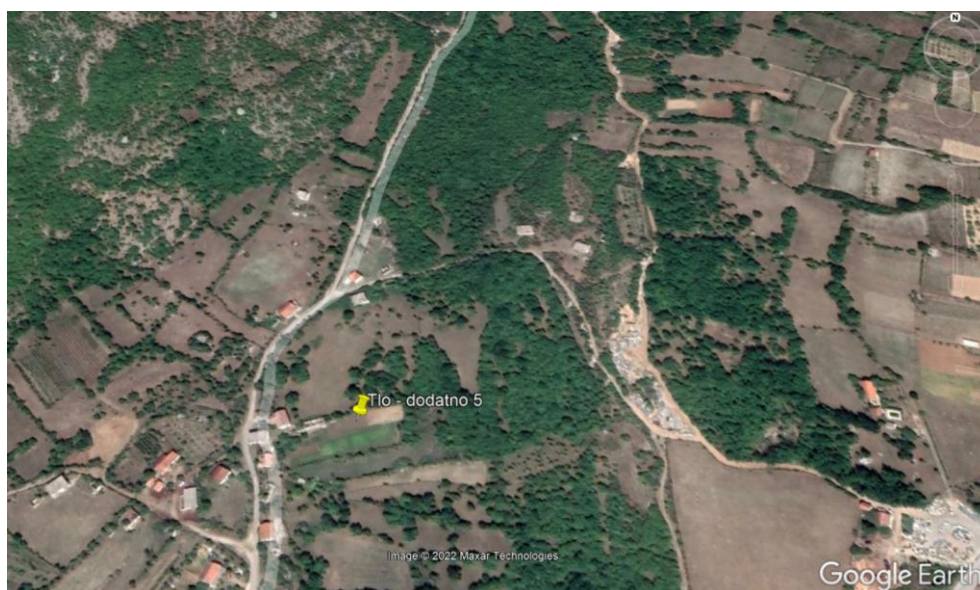
Figure 13-15: Access Road in the settlement Prigradjani
